EXHIBIT Y

Degradation of polypropylene *in vivo*: A microscopic analysis of meshes explanted from patients

Vladimir V. Iakovlev,¹ Scott A. Guelcher,² Robert Bendavid³

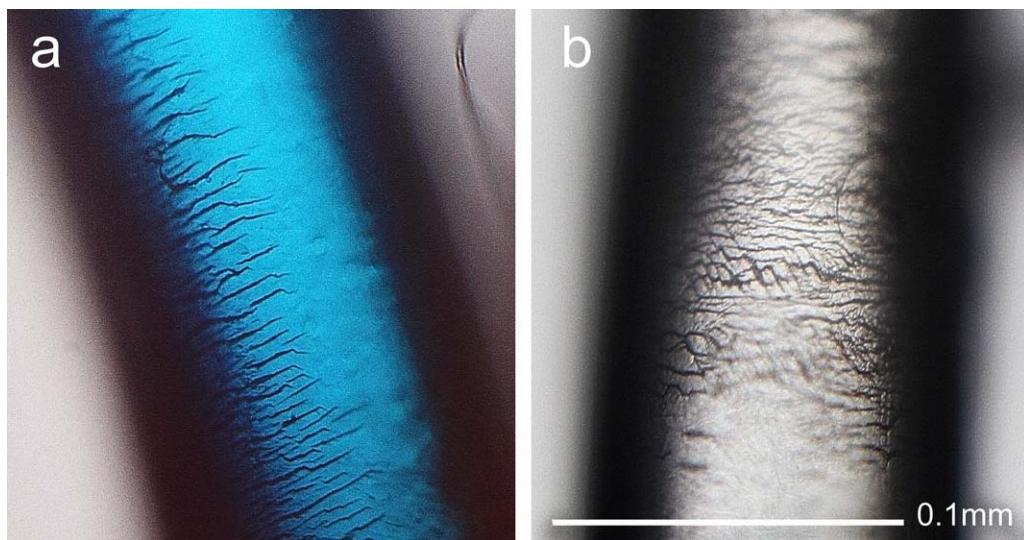
FIGURE 1. Surface of the mesh fibers immediately after explantation from the body, transvaginal sling explanted due to pain 9 years after implantation, light microscope, $\times 20$ objective with image crop. Mesh fibers at the specimen edges had no covering tissue and could be examined as they were in the body, avoiding possible artifacts of tissue removal, drying or contact with formalin. Both blue (a) and clear (b) fibers showed surface cracking. [Color figure can be viewed in the online issue, which is available at wileyonlinelibrary.com.]

In one case the mesh fibers could be assessed immediately after explantation, before tissue drying or fixation in formalin. The transvaginal sling was excised because of chronic pain 9 years after implantation. Mesh fibers at the specimen edges were free of tissue and could be examined in a conventional microscope after a rinse in saline and without additional preparation (Figure 1). There were transverse cracks at the bending points [Figure 1(a)] and patches of haphazard cracks on straighter portions of the fibers [Figure 1(b)].

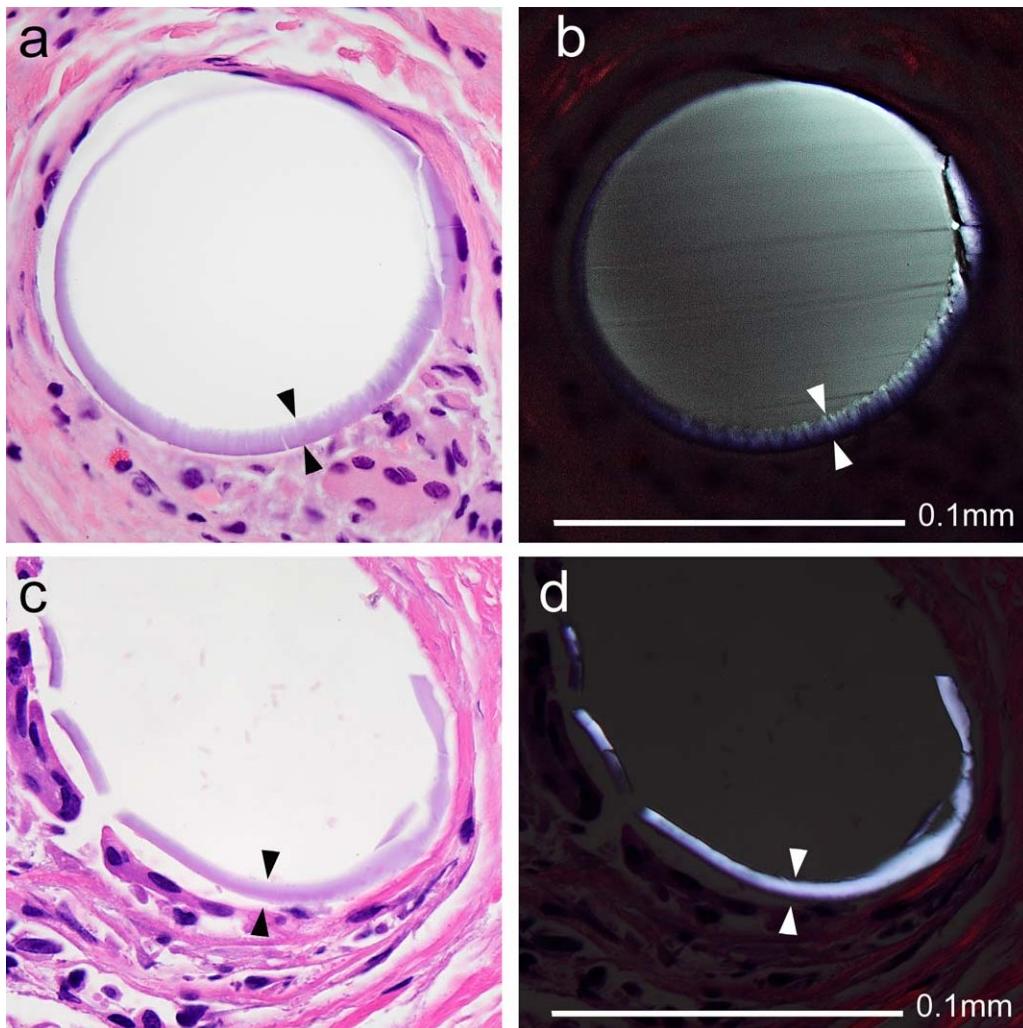
The degradation layer was detectable as a rim of purple material in the H&E stained sections while the central core of the fibers remained clear and colorless (except manufacturer's dye). The layer also showed variable staining by other histological stains indicating non-specific trapping of the dyes by

FIGURE 2. Histological sections, H&E stain, $\times 100$ objective with oil immersion. The same cross section of a clear mesh fiber in regular (a) and polarized (b) light. The fiber has a layer of staining degraded polypropylene at the surface (between arrowheads). This layer has refractile properties of polypropylene in polarized light (b). In some areas the non-degraded core of the fibers detaches during histological processing while segments of the degraded layer stay attached to the tissue. Separated degradation layer in regular (c) and polarized (d) light. At sites like this, intensity of light passing through the degraded layer cannot be attributed to light scatter from the core. Note that tissue components including collagen have a much weaker birefringence than polypropylene (b and d). [Color figure can be viewed in the online issue, which is available at wileyonlinelibrary.com.]

At optical resolution of light microscopy the stainable outer (degradation) layer was homogeneous, without detectable fibrillation. It was of a relatively uniform thickness within individual fibers and of approximately the same thickness between the fibers in the same sample. The layer showed cracks and ability to detach from the non-staining fiber core. It also showed adherence to the tissues. Where the core detached from the glass slide, the outer layer either remained on the fiber or detached from it and stayed adherent to the tissue [Figure 2(c)]. For descriptive purpose, the uniform circumferential nature, fissuring and partial peeling of the layer resembled a tree bark.

polypropylene. In polarized light, both the central core of the fibers and the outer layer showed similar refractile properties [Figure 2(b)]. The light intensity was uniform within the core while the outer layer had gradual reduction of the refractile ability toward the surface. Birefringence of the outer layer was also observed in the segments of the "bark" separated from the core [Figure 2(c,d)]. At these sites, the light brightness in the "bark" layer was due to its internal properties and could not be attributed to the scatter of light from the core. The adjacent tissue components containing collagen also showed birefringence, however of a much lower intensity. The tissue components also had a different structure and coloration.

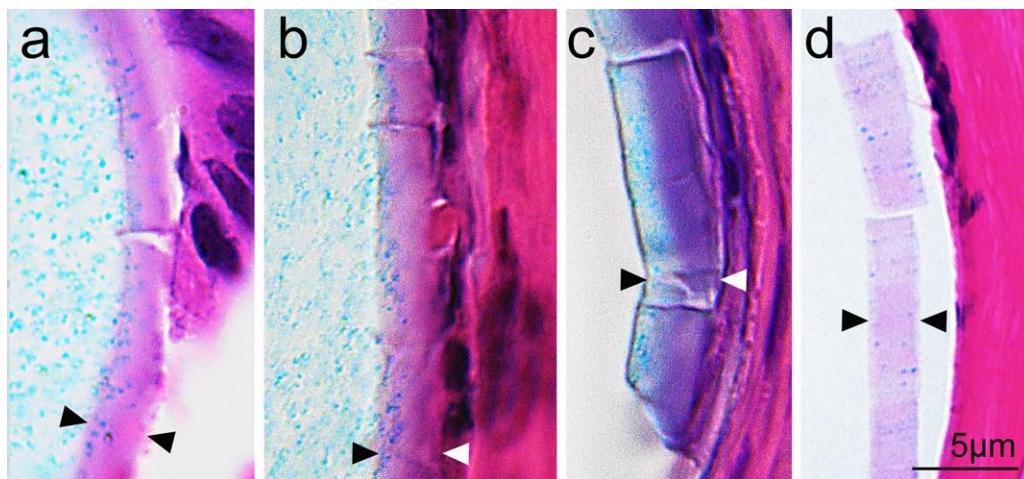
FIGURE 3. Degradation “bark” of the blue fibers manufactured with inclusion of blue dye granules, H&E stain, $\times 100$ objective with oil immersion: (a) and (b) non-degraded core (left half of the images) and the degraded layer (between arrowheads). Note that the blue granules are retained in the layer of degraded polypropylene. Within the degraded “bark,” the granules degrade and lose color toward the surface. In (c) and (d) the non-degraded core detached from the slides similarly to Figure 2(c,d). At these sites, presence of the granules in the separated “bark” cannot be attributed to an overlap with the core. [Color figure can be viewed in the online issue, which is available at wileyonlinelibrary.com.]

into the material during its manufacture (Figure 3). The granules were seen in the non-degraded core of the fibers as well as to a variable degree in the outer degradation layer. In the latter, they were detected within the “bark” remaining on the core [Figure 3(a,b)] as well as in the segments of the “bark” separated from the core [Figure 3(c,d)]. The granules were mainly seen in the deeper layers of the “bark” and were not as frequent closer to the surface, which suggests that they also undergo degradation and lose color. The finding was a direct confirmation that the “bark” originated from the same material as the core of the fibers.

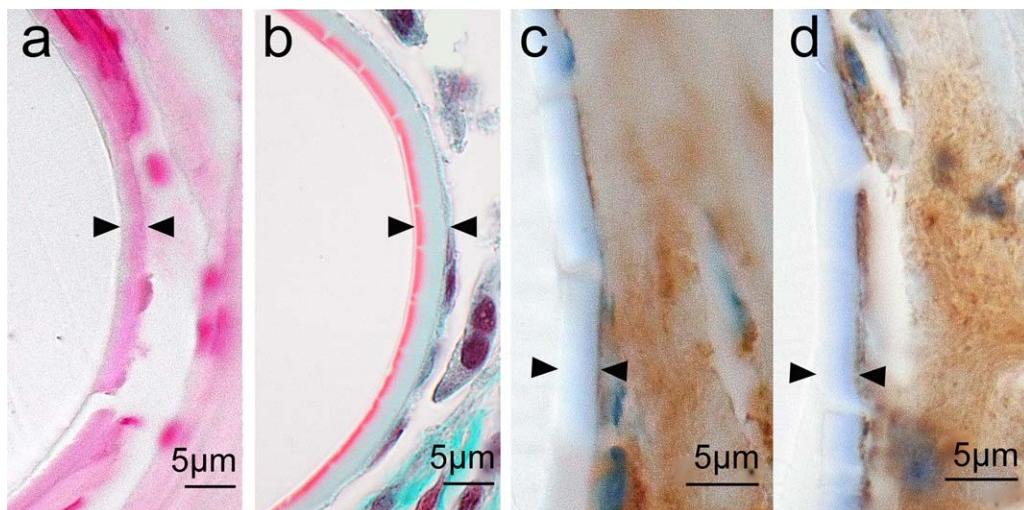
The brittleness, staining and birefringence characteristics of the “bark” were similar to those of calcium salts which are commonly deposited in degenerating tissues. Von Kossa stain was used for a sample set of 10 specimens to rule out presence of calcium salts in the outer “bark.” No calcium salts were detected in the brittle outer layer of the 10 specimens tested [Figure 4(a)].

FIGURE 4. Additional stains, all images taken with 100x oil immersion objective and cropped to a different magnification, polypropylene degradation layer is pointed between arrowheads: (a) Von Kossa stain is negative for calcium in the brittle “bark” (would stain calcium black), (b) trichrome stain shows that the deeper parts of the “bark” have smaller staining porosity (red) than those close to the surface (green) which correlates with TEM findings [Figure 6(b)], (c) immunohistochemical stain for immunoglobulin G (IgG, stained brown). IgG is present in almost all human tissues and fluids. It is deposited on the surface of degraded polypropylene but is not mixed within it. (d) Immunostain for the oxidizing enzyme of inflammatory cells myeloperoxidase (stains brown). [Color figure can be viewed in the online issue, which is available at wileyonlinelibrary.com.]

size and penetration ability. A dye (red for Masson) of a smaller molecular size and higher penetration is used in combination with a dye of larger molecular size (green). The stain showed that the deeper parts (close to the core) of the degradation layer had a finer porosity than the more superficial parts [Figure 4(b)]. This was consistent with the findings of transmission electron microscopy demonstrating a network of nanocracks/nanopores expanding toward the surface.

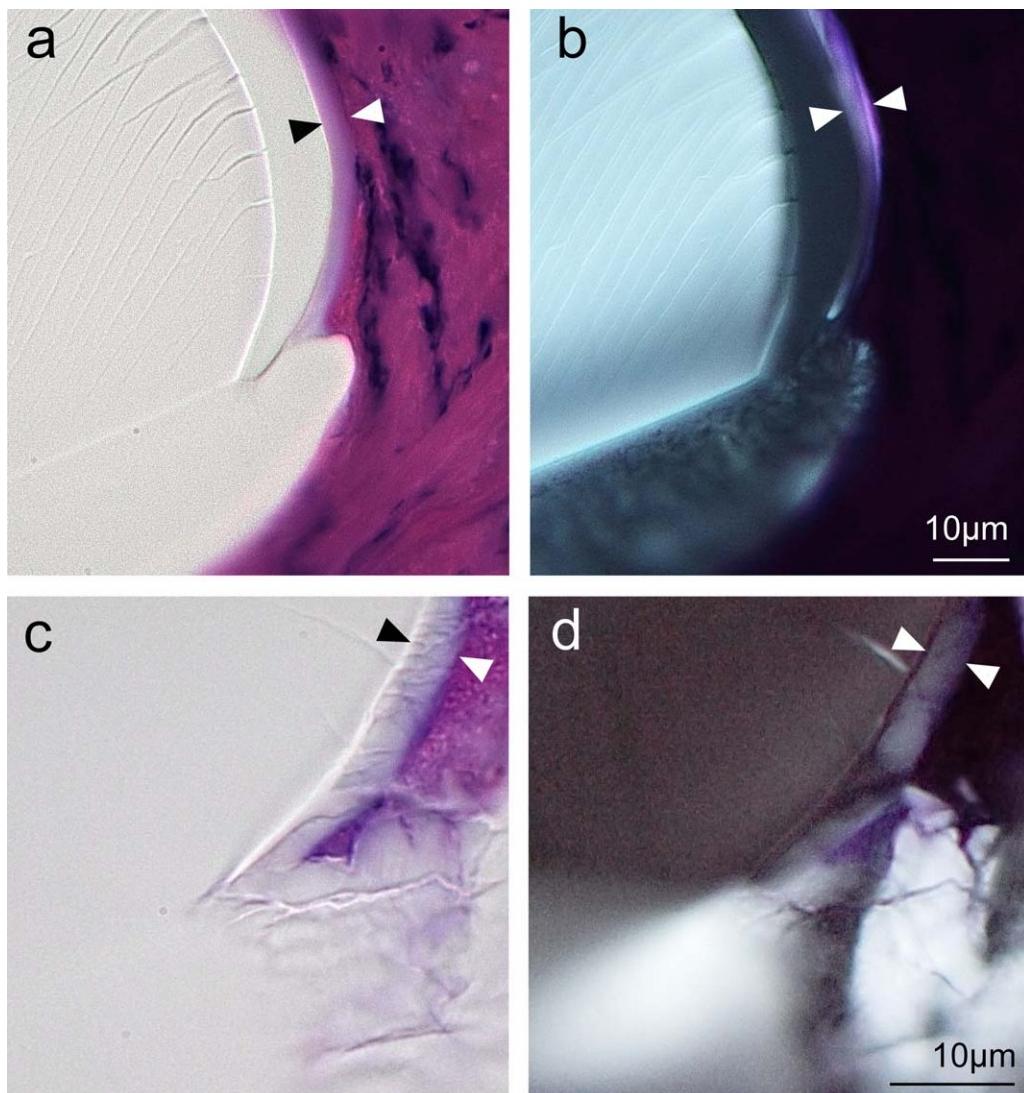
Surgical cauterity instruments cause heating of the tissues to a wide range of temperatures. There is usually a narrow zone of high temperature immediately at the tip of the instruments with a sharp drop in temperature in the deeper tissue further away. In excised specimens cauterity changes (darkening and nuclear streaming) are seen within 1–2 mm from the cauterized surface. In these areas, mesh fibers showed sites where both the outer degraded polypropylene "bark" phase and the inner non-degraded polypropylene phase melted and mixed to form a single homogeneous phase (Figure 5). The phase-mixed regions did not absorb histological dyes, thereby showing that they lack porosity observed in the degraded polypropylene. The fact that the "bark" was melted during excision surgery indicated that the degradation layer was formed in the body before the excision surgery. The finding also revealed that the fiber core and the outer "bark" are composed of materials with similar chemical compositions that are miscible with each other when heated.

FIGURE 5. Melting of both non-degraded and degraded polypropylene caused by the surgical cautery, H&E, $\times 100$ oil immersion: (a) and (b) the same site of fiber melting in regular and polarized light, (c) and (d) another site showing melding point. While molten the non-degraded core and the degradation “bark” formed a common pool of material. [Color figure can be viewed in the online issue, which is available at wileyonlinelibrary.com.]

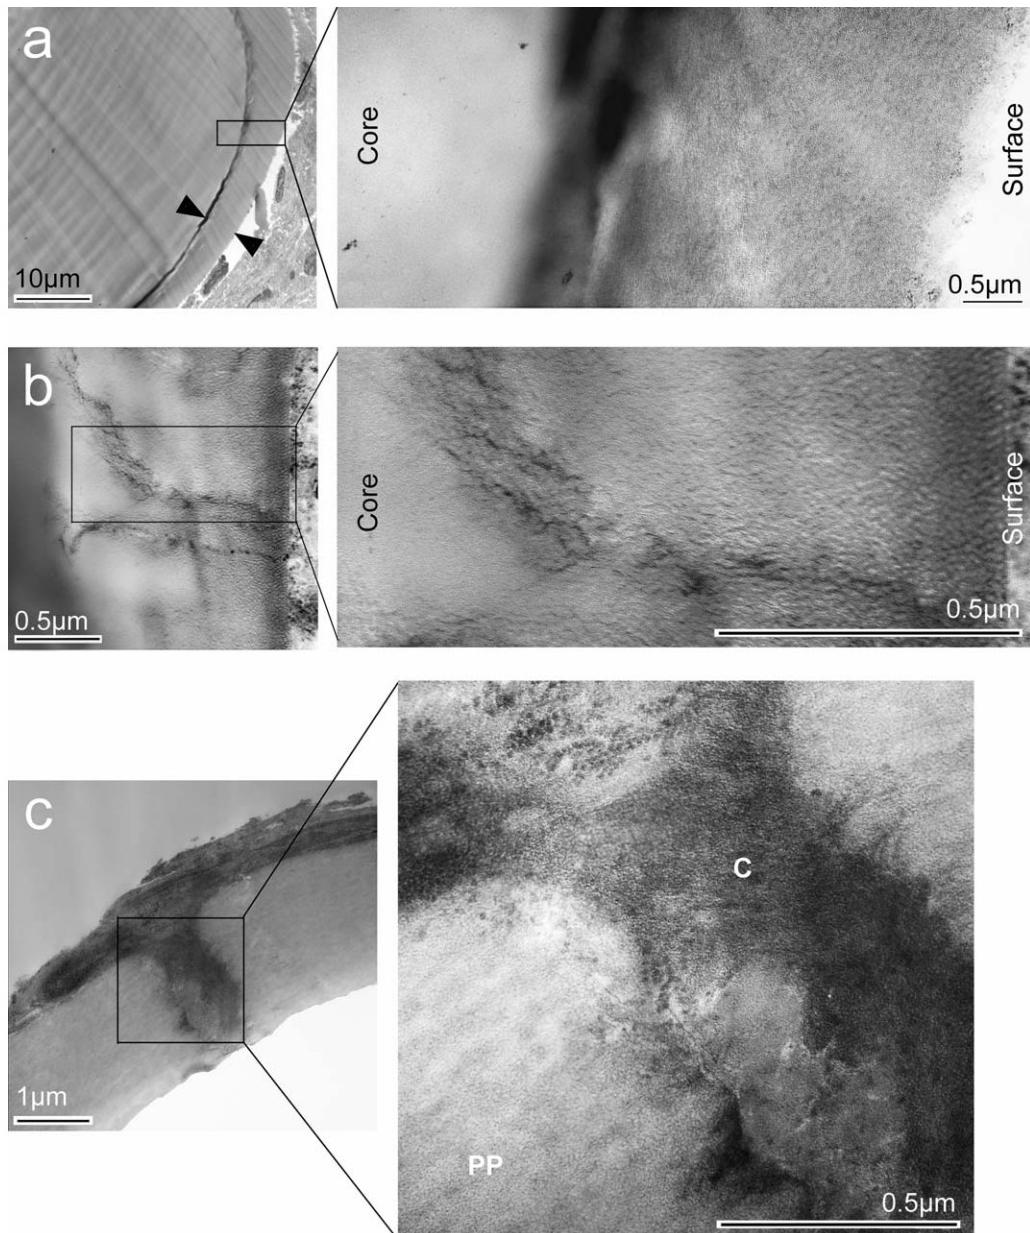
We used TEM to study the ultrastructural organisation of the degraded layer in cross sections. The mesh fibers showed an outer "bark" similar to that seen by light microscopy [Figure 6(a)]. There were no fibrillary (collagen, amyloid etc.) or other structures of connective tissue matrix within the "bark". Material composition of the outer layer and the core showed similar electron density; however, at high magnification the outer "bark" was noticeably more granular, especially toward the surface [Figure 6(a), insert].

The "bark" material had a lattice of fine branching cracks (nanocracks). This network of nanocracks was sparse closer to the core and expanded toward the surface [Figure 6(b)]. As seen in Figure 6(b) in addition to the nanocracks there were also occasional larger cracks occurring at random. These larger cracks seen by TEM corresponded to the cracks seen by light microscopy either on the surface (Figure 1) or in cross sections (Figure 2).

The "bark" either had a gradual transition into the core [Figure 6(b)] or showed a zone of circumferential fissuring partially separating it from the core [Figure 6(a)]. The mechanisms of "bark" separation from the core and formation of the larger cracks are likely linked since the cracks tended to turn at the interface between the "bark" and the core [Figure 6(b)]. The forces which produced the transverse (radial) cracks also acted as shear forces between the "bark" and the core.

An important finding was the detection of inflammatory cells partially migrated into and trapped within the fissures as shown in Figure 6(c). The shape of widened crevices and the depth of penetration indicated an active *in vivo* cellular migration. This phenomenon was observed at two separate sites.

FIGURE 6. Transmission electron microscopy. (a) Low power magnification of a cross-sectioned mesh fiber shows the degradation layer similarly to light microscopy, the insert shows an image composed of three high power fields to reconstruct the transition between the non-degraded core and the degradation “bark.” Note the fine nanocracks/nanopores in the degraded material. (b) Outer part of the fiber with gradual transition between the non-degraded core and the degraded polypropylene at the surface. The lattice of nanocracks expands toward the surface (left to right). There are also two larger cracks which start perpendicular to the surface but then turn at the interface between the core and the degraded layer. (c) A part of inflammatory cell (labeled C in insert) is trapped in a fissure within the degraded polypropylene (PP). Higher magnification (insert) shows cellular membrane at the cell-polypropylene interface (left wall of the fissure) and cellular organelles in the cell (chains of rounded structures, likely ribosomes).

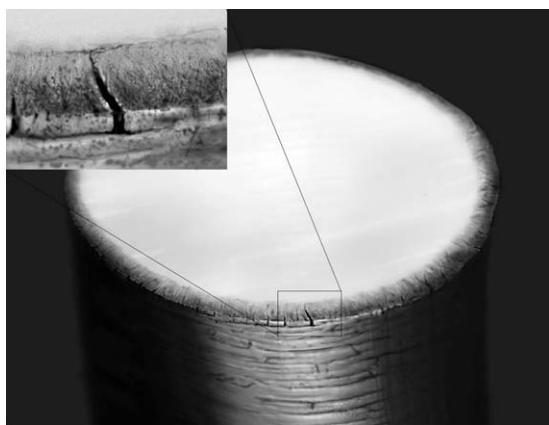
For better demonstration of the degradation "bark" we used light microscopic and TEM images to generate a 3-dimensional restoration of a mesh fiber (Figure 7).

FIGURE 7. A three-dimensional restoration of a cross sectioned mesh fiber.

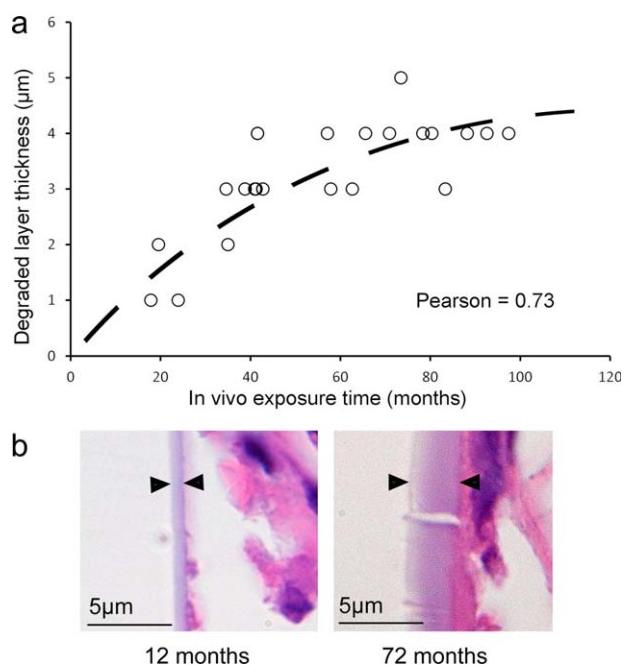
Out of all the specimens, 23 samples of explanted midurethral slings formed the largest group of meshes from the same manufacturer, of identical mesh type and with reliable records of implantation and excision dates. The range of *in vivo* interval (between implantation to excision) in the group was 18–97 months (mean 53). There was a good correlation (Pearson = 0.73) between the thickness of the degradation layer and the duration of *in vivo* exposure indicating that the thickness of degraded material grows while the mesh is in the body [Figure 8(a,b)]. There was a trend for a more rapid initial growth with gradual plateau subsequently.

FIGURE 8. Duration of *in vivo* exposure versus thickness of degraded layer in a group of explants of the same manufacturer and the same mesh design. (a) Thickness of the degradation "bark" increased over the years *in vivo* (Pearson correlation = 0.73). Note the trend of plateauing after 5–6 years. There was no correlation of the thickness with the duration of specimen storage in formalin (not shown, Pearson = -0.06). (b) Comparison of the "bark" in meshes explanted after 12 and 72 months in the body, H&E, $\times 100$ objective with oil immersion, images cropped to the same magnification factor. [Color figure can be viewed in the online issue, which is available at wileyonlinelibrary.com.]
